#### (4) GROINS STABILITY - EGYPT (2006) – Slope Stability of Large Size Groins

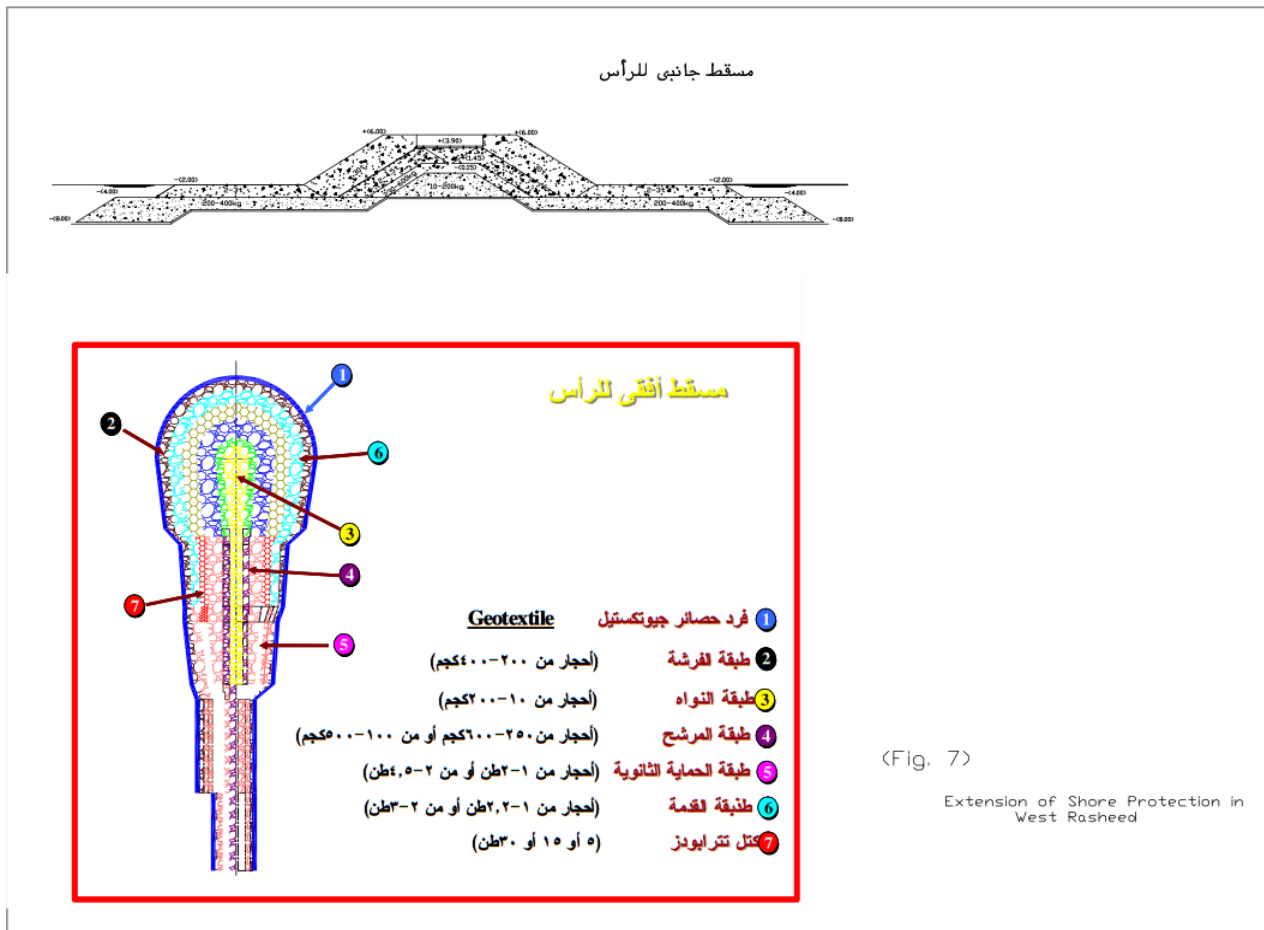
The project location is to the east of Alexandria at Burrullus and owned by General Authority for Shores Protection, Ministry of Irrigation and Water Resources. The project target is to control erosion and sedimentation of the sea where the rate of erosion had reached a 30 m per year. Nine groins were designed with 5 kilometers apart, where eight of them were successfully constructed. The last groin location geological profile has a thick shallow layer of soft clay that hindered the work progress in excavation and up fill. The design of the groin cross section shape has been altered to increase the safety factor against rotational sliding which has been dropped below coded value by the presence of the soft clay layer.
